# Corrosion Report

Equipment Location ID 0955-031-002  
 Equip. Location Descrip. NAPHTHA TO C-1100 ATCR OR CRAZY CORNER

# History Brief

Date Not Available:	9/26/2006	Date Available:	09/26/2006
History Brief Date:	09/26/2006	History Brief ID:	VI-0609160863
Event Type:	Failure	In- Service Date:	09/26/2006
Equipment ID:	0955-031-002	Critical:	L
Asset ID:	0000110630	Reference Material:	
Work Order Nbr:		Incident Event ID:	
History Type:	FXD	Inspection Date:	09/26/2006
Asset Type:	221	Inspection Type:	
Cost Center:	K.DCRR00281		
Unit:	0955 - 4 CRUDE UNIT PLT 11		
Headline:	CUI Dmg To 0.04" @ Crazy Corner Ovhd Ell, Reco To Rplc

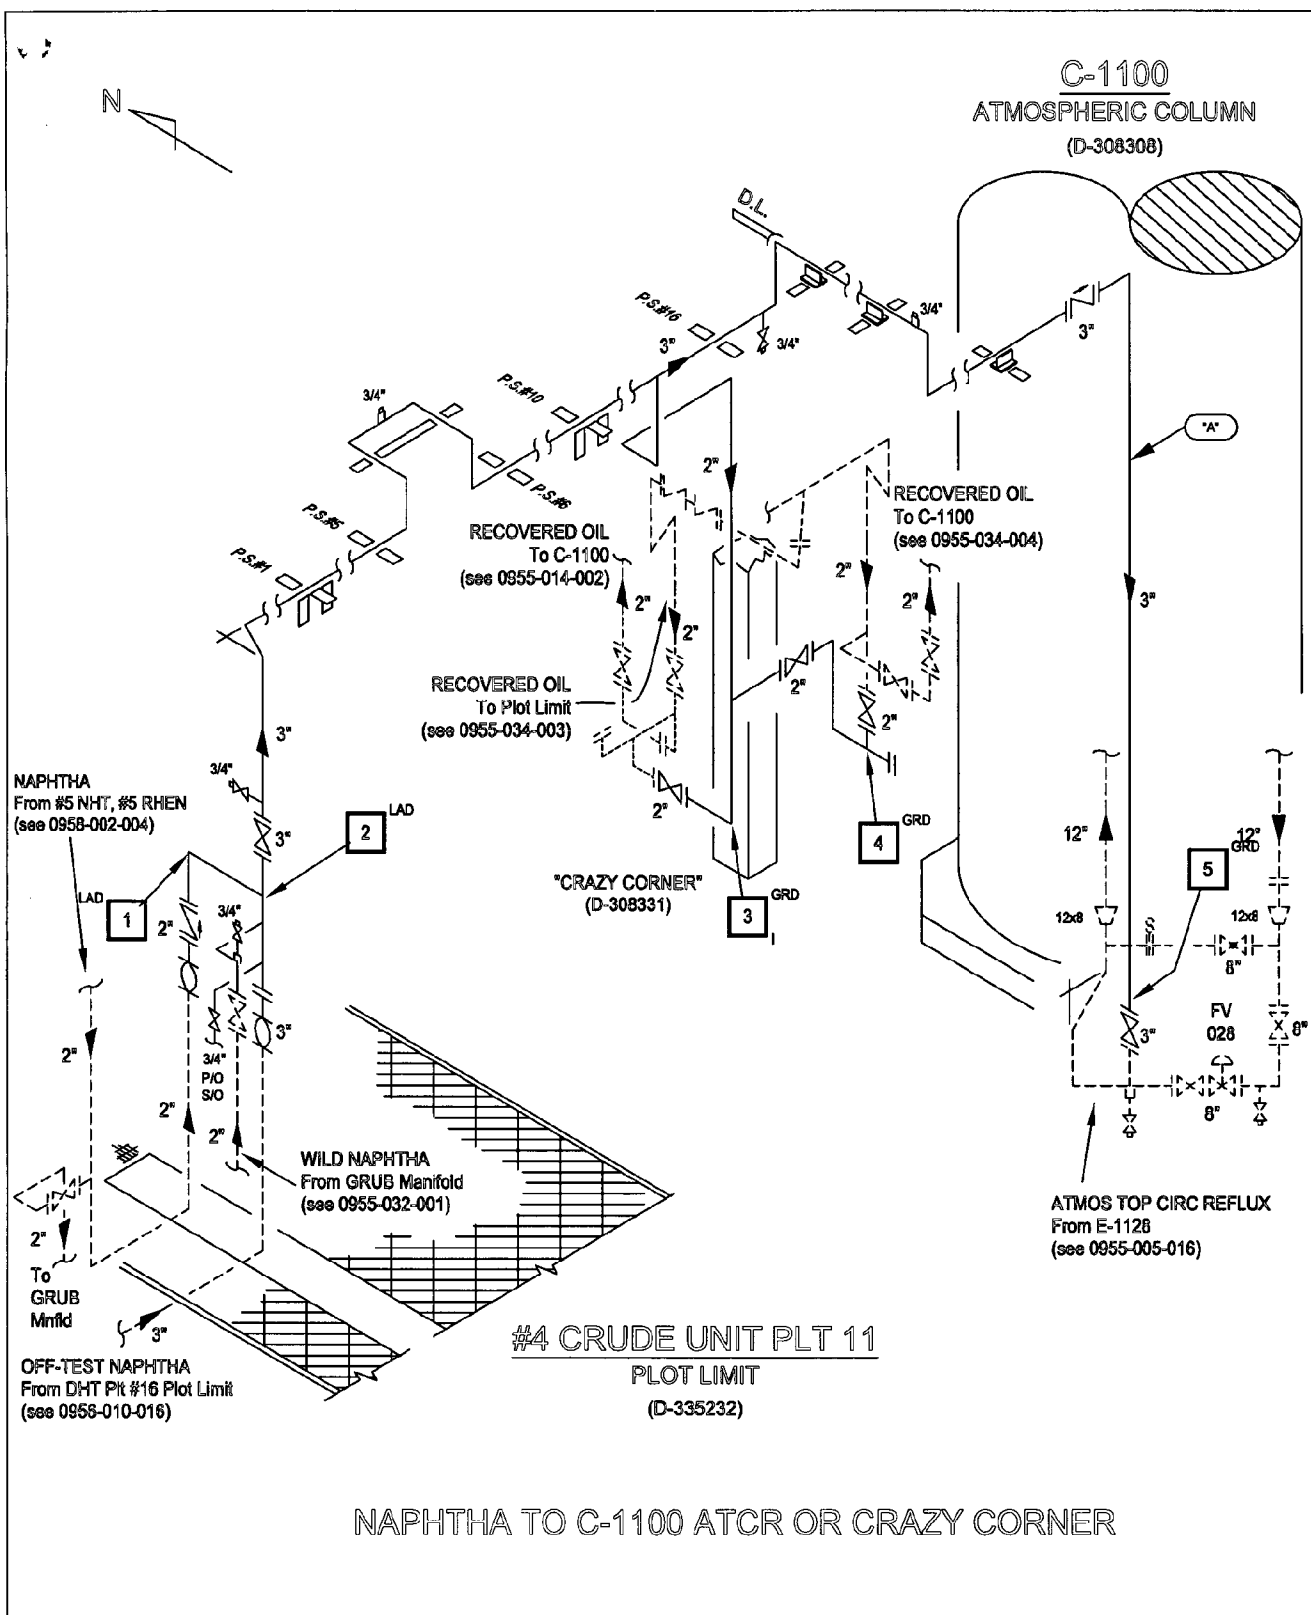
During the 9/06 4 Crude CUI Inspection Project, the branch piping and 1st ell down from the header in the east-west pipeway (near P/S # 16) was found severely corroded due to CUI. The worst corrosion was on the vertical straight section in the HAZ of the upper ell to straight weld (down to 0.04" by RT). The ell is located above TML # 3; total estimated footage of damaged line was ~3'.

A recommendation (REC-55916) was issued to replace the corroded ell and straight sections of line.
